### E1112:BH03 - A Axis

PROJECT: Weymouth  
 SITE: E1112  
 INSTALLATION: BH03  
 COMPANY: A.I.S.  
 CLIENT:  
 NOTE: Eastern Side of Landslip.

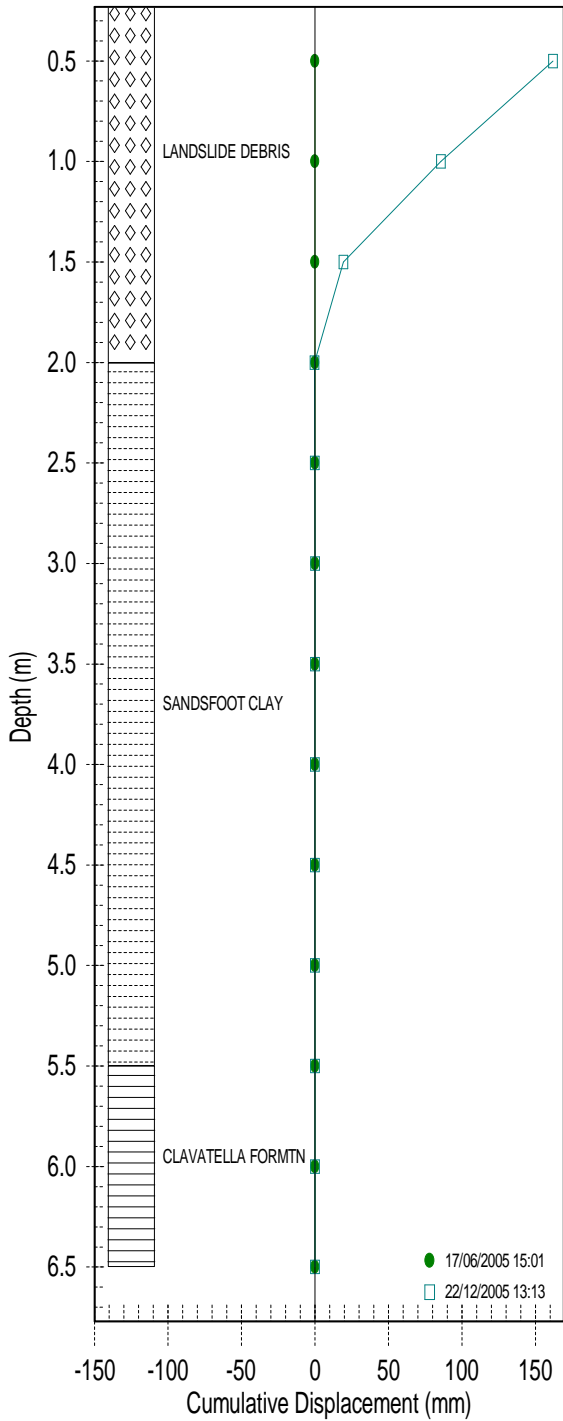
Initial survey: 17/06/2005 15:01

Accumulative Deflection Data in A Axis (mm):

Depth (m)	17/06/200 5 15:01	22/12/200 5 13:13
0.5	0.00	161.95
1.0	0.00	85.70
1.5	0.00	19.30
2.0	0.00	-0.35
2.5	0.00	-0.15
3.0	0.00	0.05
3.5	0.00	0.00
4.0	0.00	-0.05
4.5	0.00	-0.10
5.0	0.00	-0.05
5.5	0.00	0.00
6.0	0.00	0.00
6.5	0.00	0.00

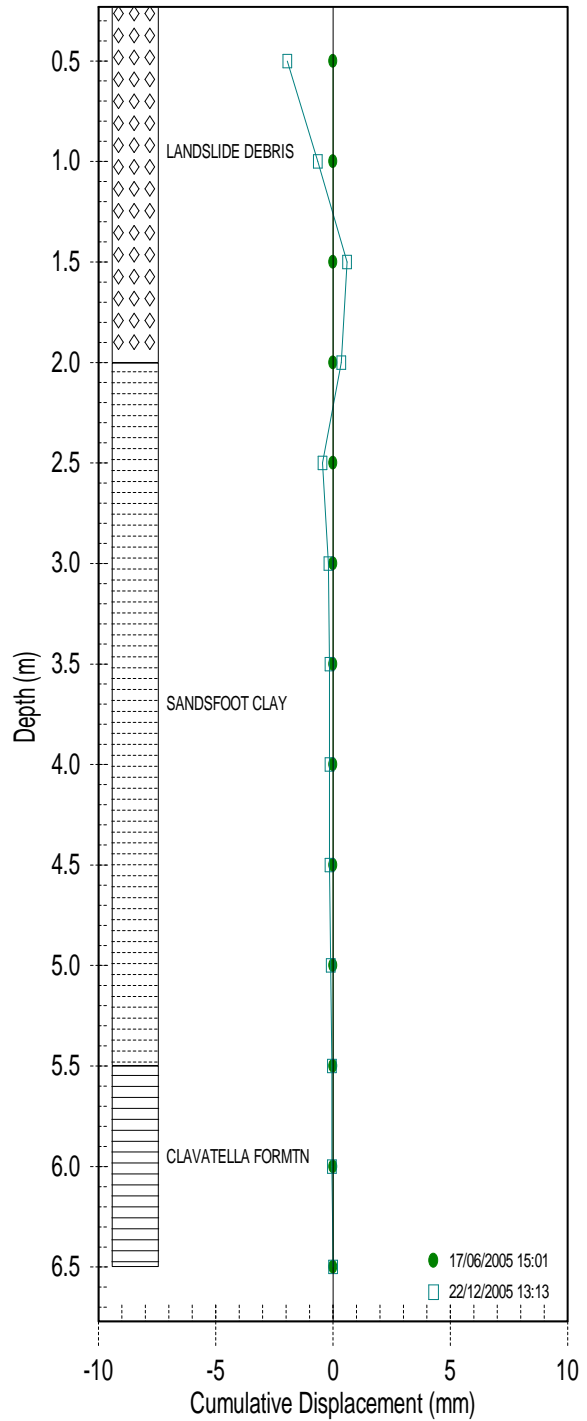
### E1112:BH03 - B Axis

Initial survey: 17/06/2005 15:01

Accumulative Deflection Data in B Axis(mm):

Depth (m)	17/06/200 5 15:01	22/12/200 5 13:13
0.5	0.00	-1.95
1.0	0.00	-0.65
1.5	0.00	0.60
2.0	0.00	0.35
2.5	0.00	-0.45
3.0	0.00	-0.20
3.5	0.00	-0.15
4.0	0.00	-0.15
4.5	0.00	-0.15
5.0	0.00	-0.10
5.5	0.00	-0.05
6.0	0.00	-0.05
6.5	0.00	0.00

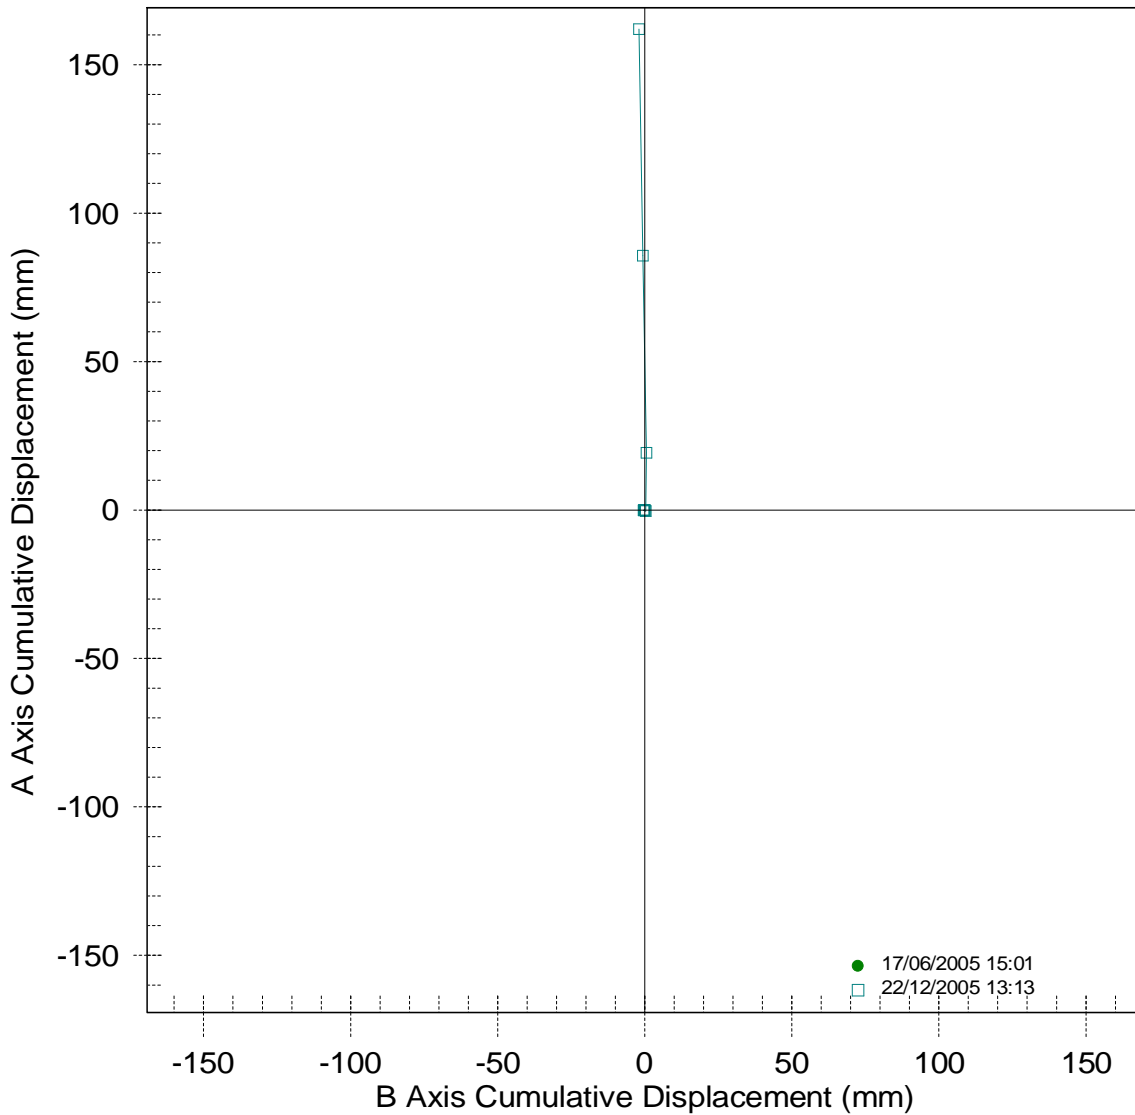
# E1112:BH03 - A Axis vs B Axis

Initial survey: 17/06/2005 15:01
